CLIENT: **Easy Rock**
2260 South Haven, Unit B
Ontario, CA. 91761
Attn: Mark Lynders

Test Report No: RJ3245

SUBJECT: Structural Performance Testing of composite stone panels.

SAMPLE ID: Easy Rock Stacked Stone composite panels with dimensions of 12" x 48" x approximately 1" thick.

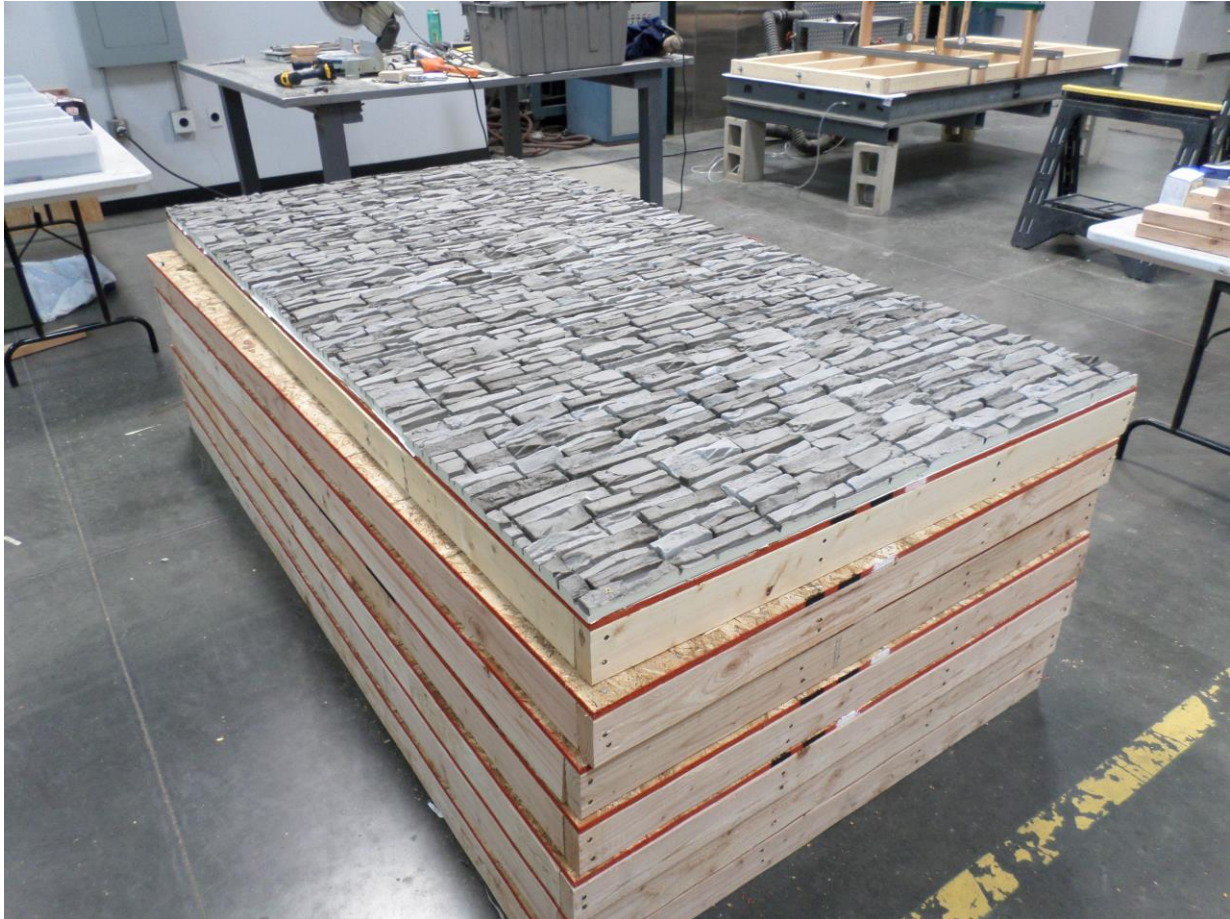
Photograph No.1
Composite Stone Test Panels

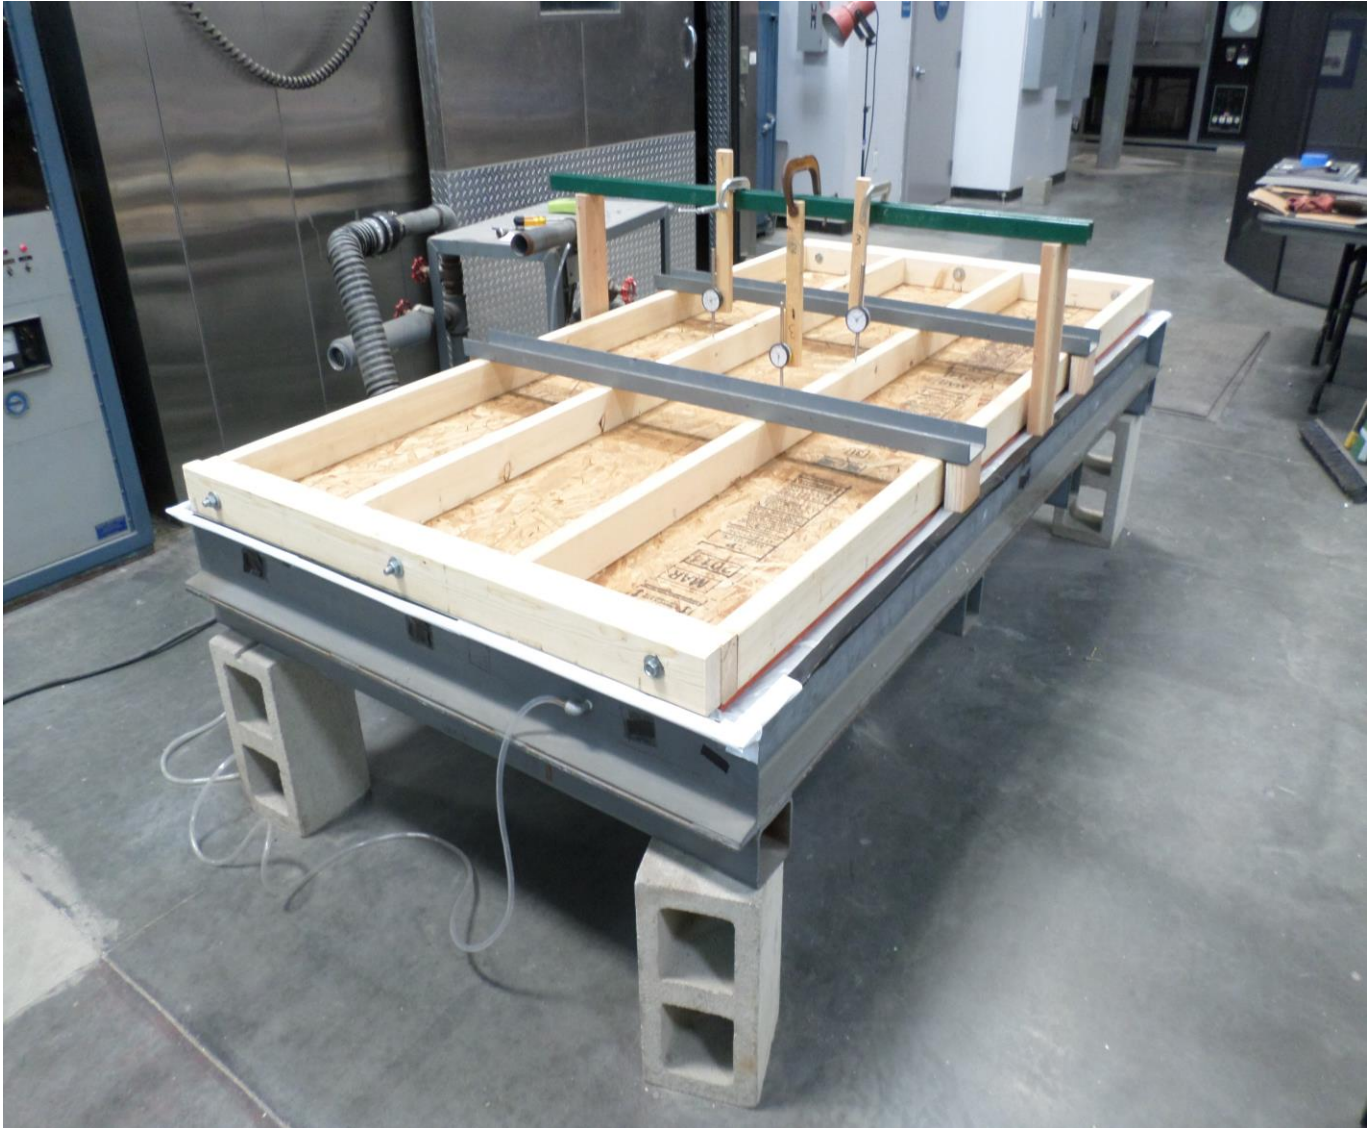
Photograph No.2
Negative Load Test Set-Up

For negative load tests, the panels were individually placed horizontally, face down, on the test chamber and an airtight seal provided around the perimeter of the panel. To prevent failure in the framing, two, 6-inch wide steel "C" channels were attached across the back of the studs, approximately 32 inches apart. The loads were uniformly applied to the exterior side of the panel using a reversible controllable blower system.

A photograph of the negative load test set-up is provided in the appendix of this report.

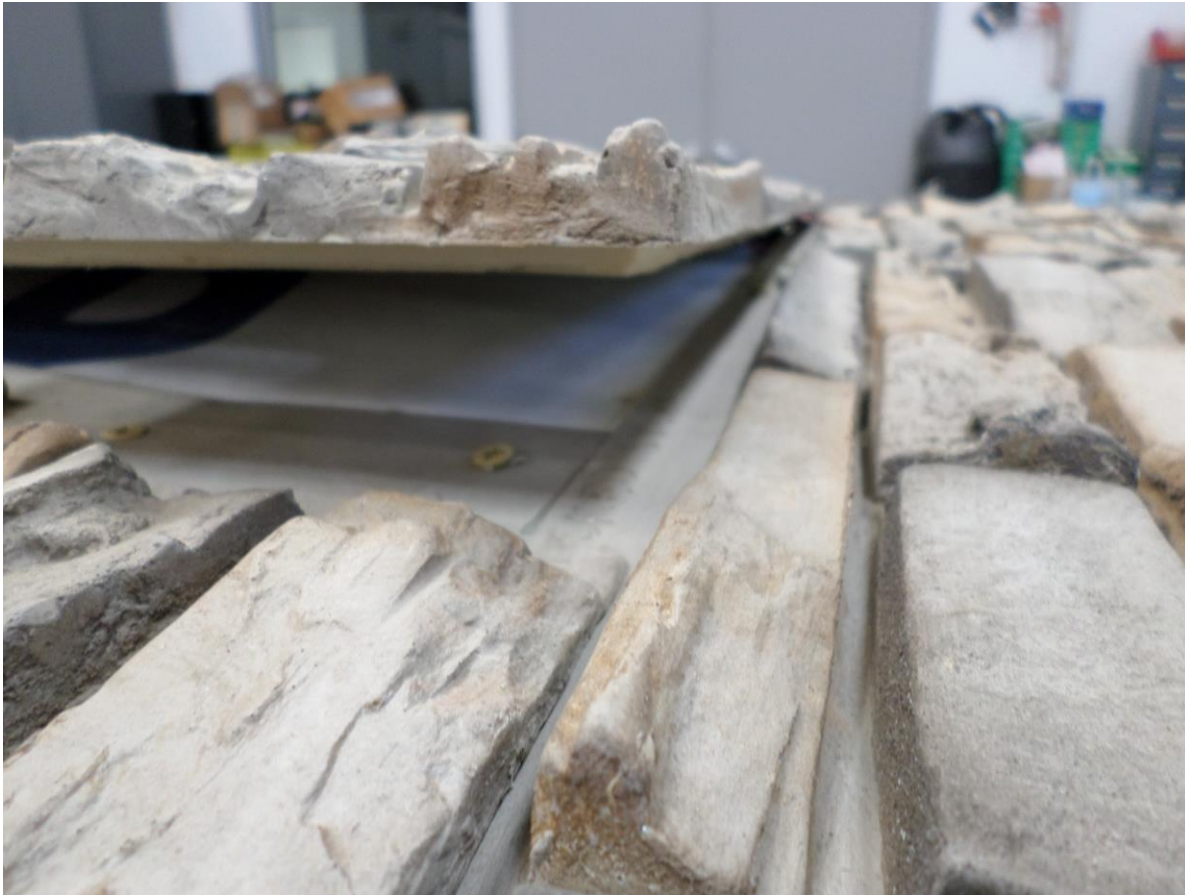
Photograph No.3
Typical results of the negative load test
Tongue and groove failure

Panel #	Observations
1	At a test load of 100 psf, the heads of the deck screws pulled through the foam panels. Failure at the tongue and groove joint was also observed.
2	At a test load of 122 psf, the heads of the deck screws pulled through the foam panels. Failure at the tongue and groove joint was also observed.
3	At a test load of 126 psf, the heads of the deck screws pulled through the foam panels. Failure at the tongue and groove joint was also observed.
	The average ultimate test load for the three panels is 116 psf which is equivalent to a wind speed of 214 mph.

A photograph showing the typical mode of failure is provided in the appendix of this report.
